## COMMERCIAL WINDSTORM MITIGATION REPORT

North East Garden Apartments Condominium Association, Inc.

As of 3/5/2020

FPAT File# MUD2014384

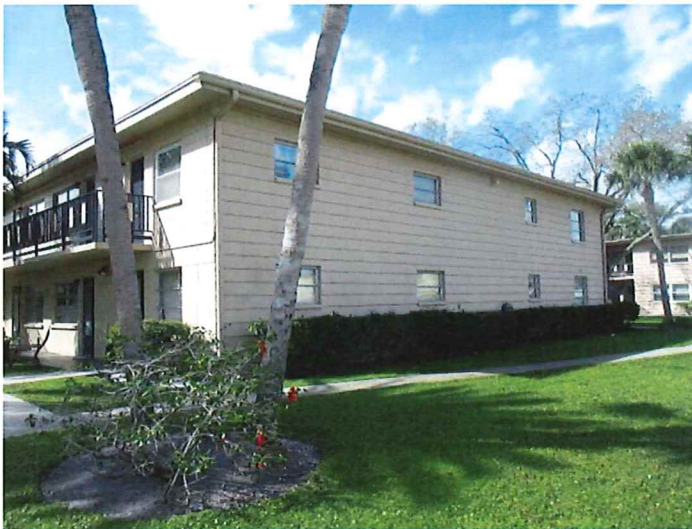
Exterior Elevation

| 5. <b><u>Roof Geometry:</u></b><br>Comments: | <b>Flat Roof</b><br>Inspection verified a flat roof shape. |

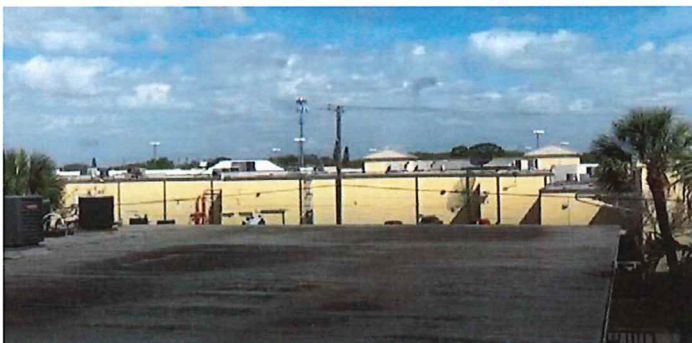
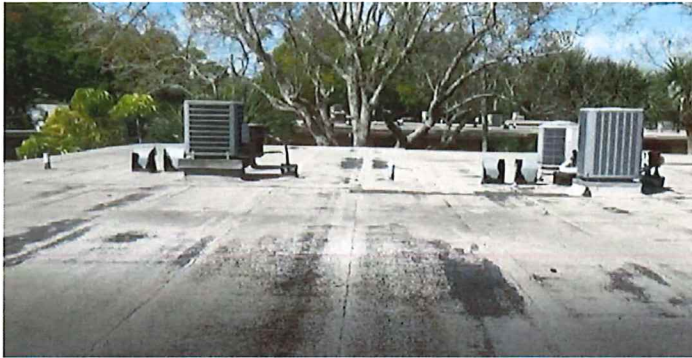
Roof Construction

| 2. <b><u>Roof Covering:</u></b><br>Comments: | <b>FBC Equivalent</b><br>The roof covering was replaced in 2006. The roof permit was confirmed and the permit number is 06-6001286. This roof was verified as meeting the building code requirements outlined on the mitigation affidavit. |
| 3. <b><u>Roof Deck Attachment:</u></b><br>Comments: | <b>No Attic Access</b><br>At time of inspection there was no attic access. |

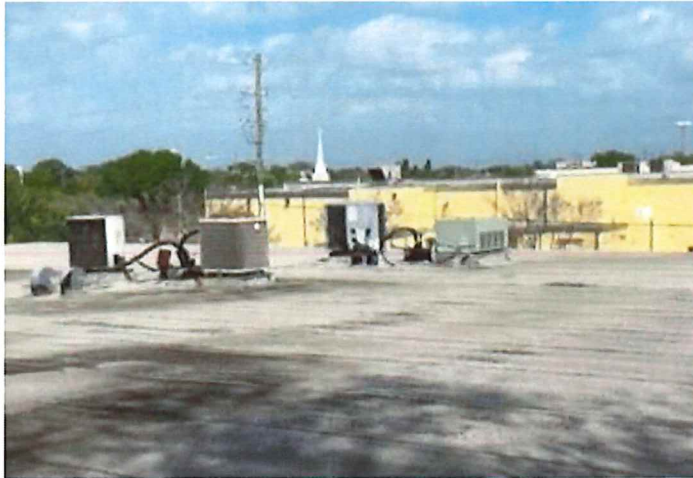
Roof Construction

| <b>2. <u>Roof Covering:</u></b><br>Comments: | <b>FBC Equivalent</b><br>The roof covering was replaced in 2007. The roof permit was confirmed and the permit number is 07-1001252. This roof was verified as meeting the building code requirements outlined on the mitigation affidavit. |

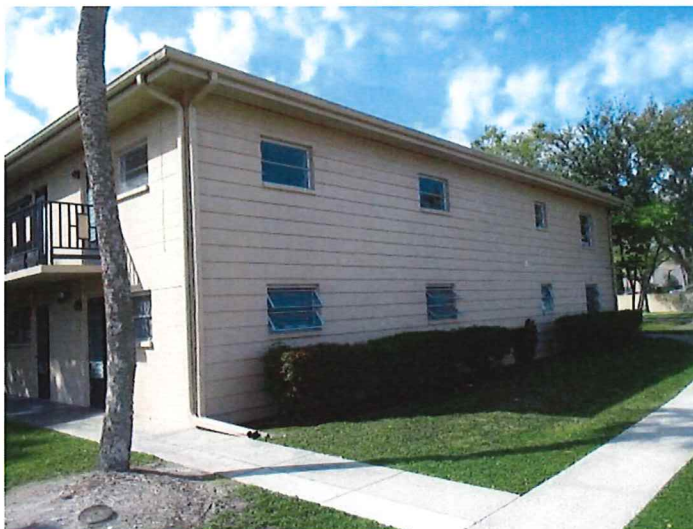
Exterior Elevation

| <b>7. <u>Opening Protection:</u></b><br>Comments: | <b>None or Some Glazed Openings</b><br>Inspection verified no opening protection. |

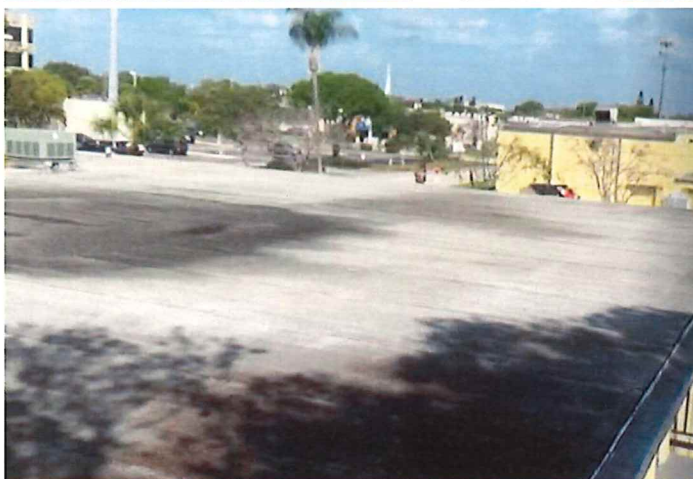
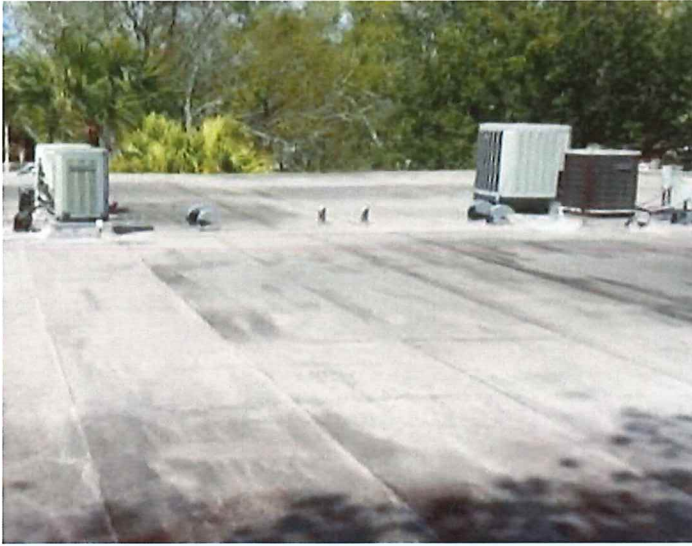
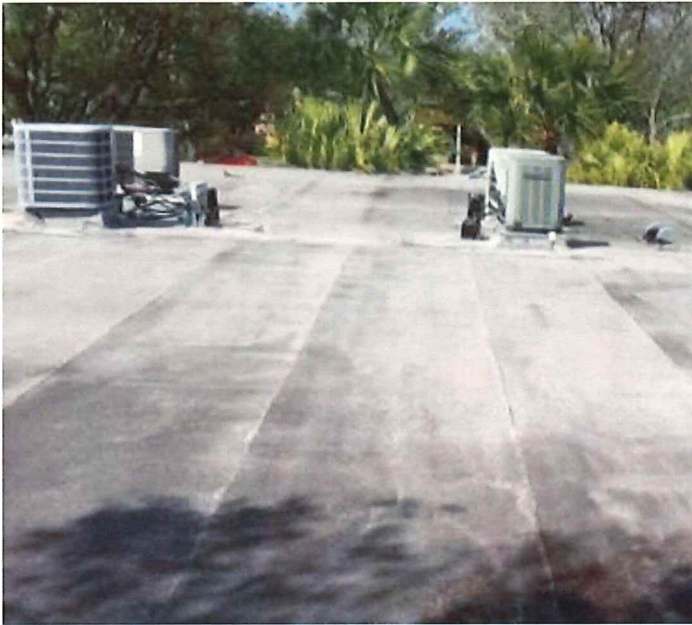
Roof Construction

| <b>2. <u>Roof Covering:</u></b><br>Comments: | <b>FBC Equivalent</b><br>The roof covering was replaced in 2006. The roof permit was confirmed and the permit number is 06-9000650. This roof was verified as meeting the building code requirements outlined on the mitigation affidavit. |
| <b>6. <u>SWR:</u></b><br>Comments: | <b>Unknown or Undetermined</b><br>At time of inspection there was no attic access. |
